## **Technical Memorandum**

### **Surface Impoundment Cap Evaluation for Erosion**

**Gulfco Marine Maintenance Superfund Site  
906 Marlin Avenue  
Freeport, Brazoria County, Texas  
EPA Identification No. TXD0055144539**

December 2010  
Revision 01  
EA Project No. 14342.67

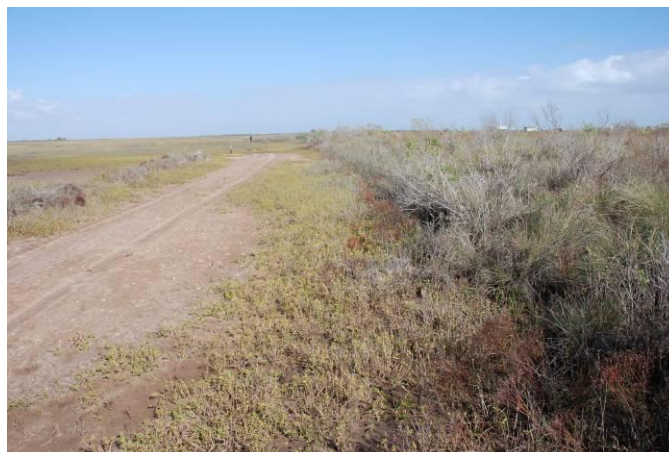
The elevation of the surface impoundment cap is approximately 2 feet higher than the surrounding existing natural surface grade. The existing cap is approximately 2.5 to 3.5 feet thick. The clay cap appeared to be in good condition with no surface cracking during the site investigation. The photo below shows the typical elevation differences between the cap, to the right, and the surrounding areas.

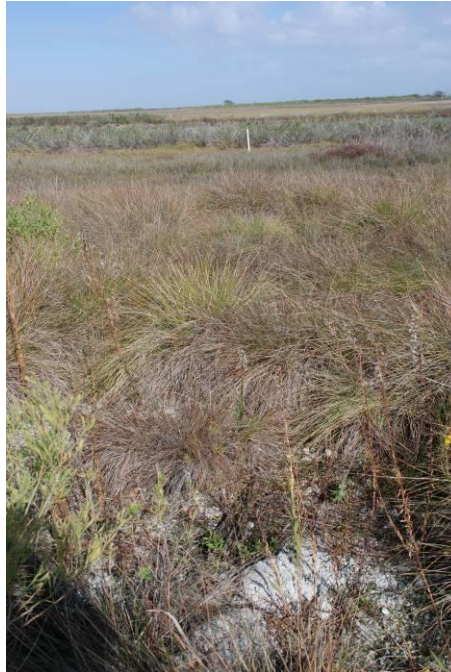
The surface of the clay cap is covered with a layer of oyster shells and vegetation. Cap vegetation consists of mostly grasses with some brush. The majority of the brush is located along the perimeter of the cap with isolated patches within the interior portions of the cap. The photo below shows typical cap vegetation.

There is no obvious maintenance of the cap as evidenced by the presence of woody vegetation around the perimeter of the cap and on a few areas on top of the cap. The roots of woody vegetation could compromise the clay layer of the cap and allow infiltration and contribute to migration of contaminants away from the confines of the former impoundment.

Therefore, the current impoundment cap clay layer does not meet the requirements for a Class 1 impoundment, nor does the current surface layer. The cap is vegetated but woody growth needs to be cut or removed.

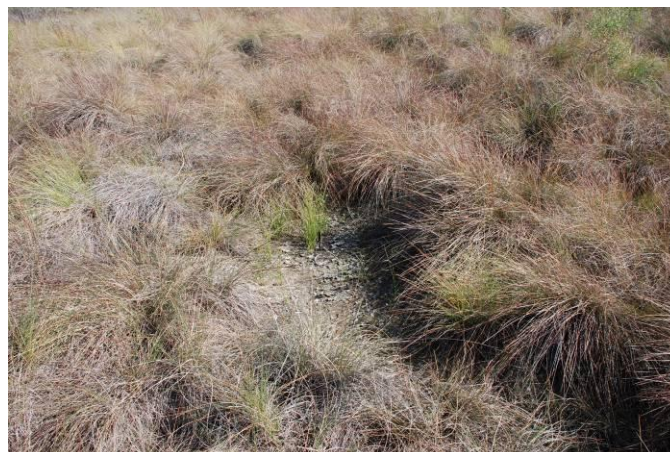
Evidence of vehicular traffic along the perimeter of the cap was observed during the site investigation. Wheel tracks have formed ruts in portions of the vegetation along the western side of the cap. The rutting was generally no more than 3 inches deep with one location found to be approximately 6 inches deep. The photo below is an example of typical vehicle paths through the ground cover.

Even though there is no evidence of erosion, the obvious rutting of the cap on the western edge has not been repaired and could also lead to compromise of the clay layer.

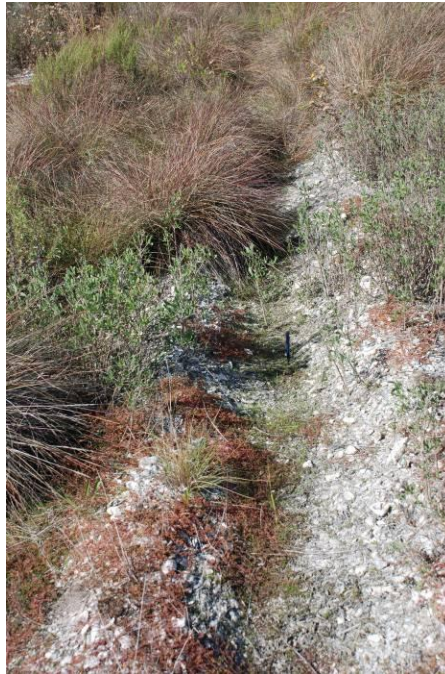
The photo below details the area of deepest rutting (approximately 6-inches).
